Report

Determination of some material properties of a Senso Terrazzofloor

Report number: 89204600.01

Date: August 11th, 2014

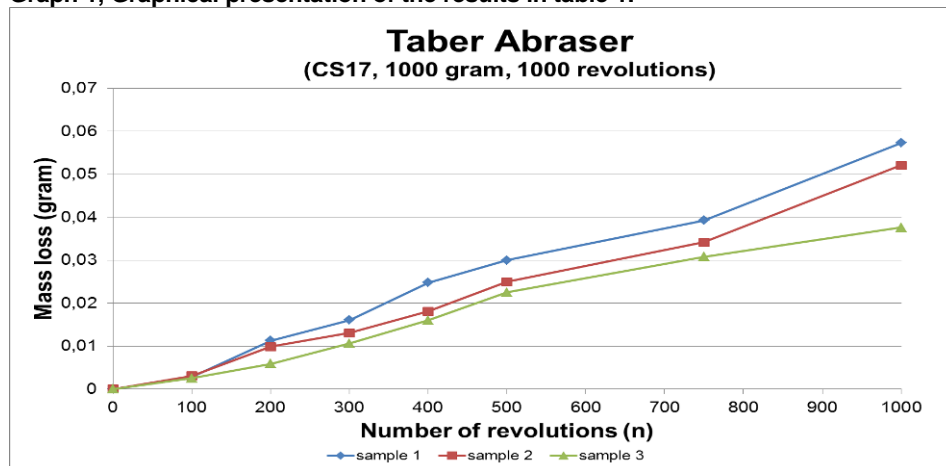
Number of revolutions (n)	Mass loss (gram)		
	Sample 1	Sample 2	Sample 3
100	0.0028	0.0031	0.0025
200	0.0113	0.0099	0.0059
300	0.0161	0.0131	0.0106
400	0.0248	0.0181	0.0160
500	0.0300	0.0250	0.0225
750	0.0393	0.0342	0.0308
1000	0.0573	0.0521	0.0376

Graph 1, Graphical presentation of the results in table 1.

The results of the wear resistance tests show a mass loss of approximately 0.049 gram when tested during 1000 revolutions with CS 17 wheels and a 1 kg load.

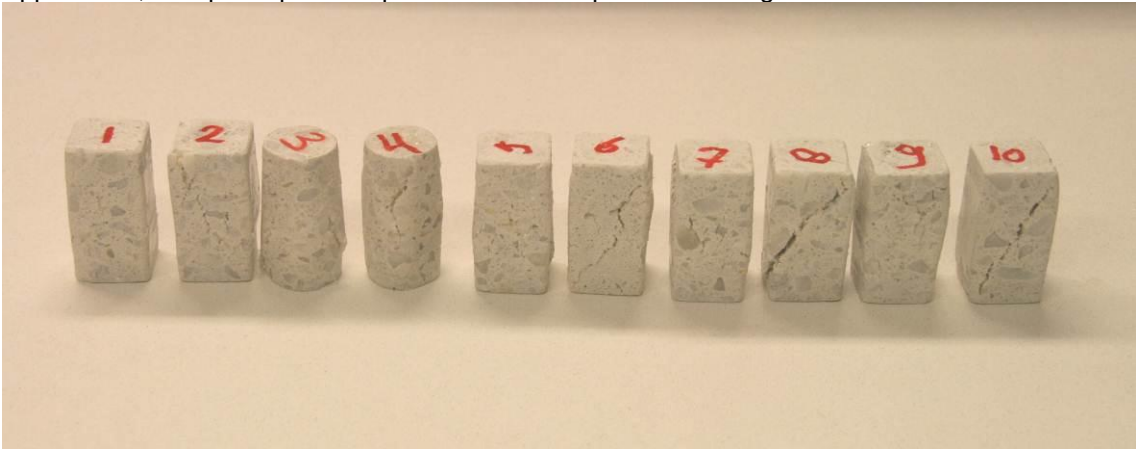
Photo 1, Samples upon completion of the compression strength test.

The samples upon completion of the compression test are shown on photo 1 in appendix A.

Test	Compressive strength (N/mm ²)	Compressive strength (PSI)
1	15.58	2422
2	16.80	2145
3 (cylindrical)	16.70	2260
4 (cylindrical)	14.79	2436
5	16.53	2397
6	16.03	2325
7	16.26	2359
8	16.81	2438
9	16.41	2380
10	15.89	2305
Mean	16.18	2347
Standard deviation	0.64	92

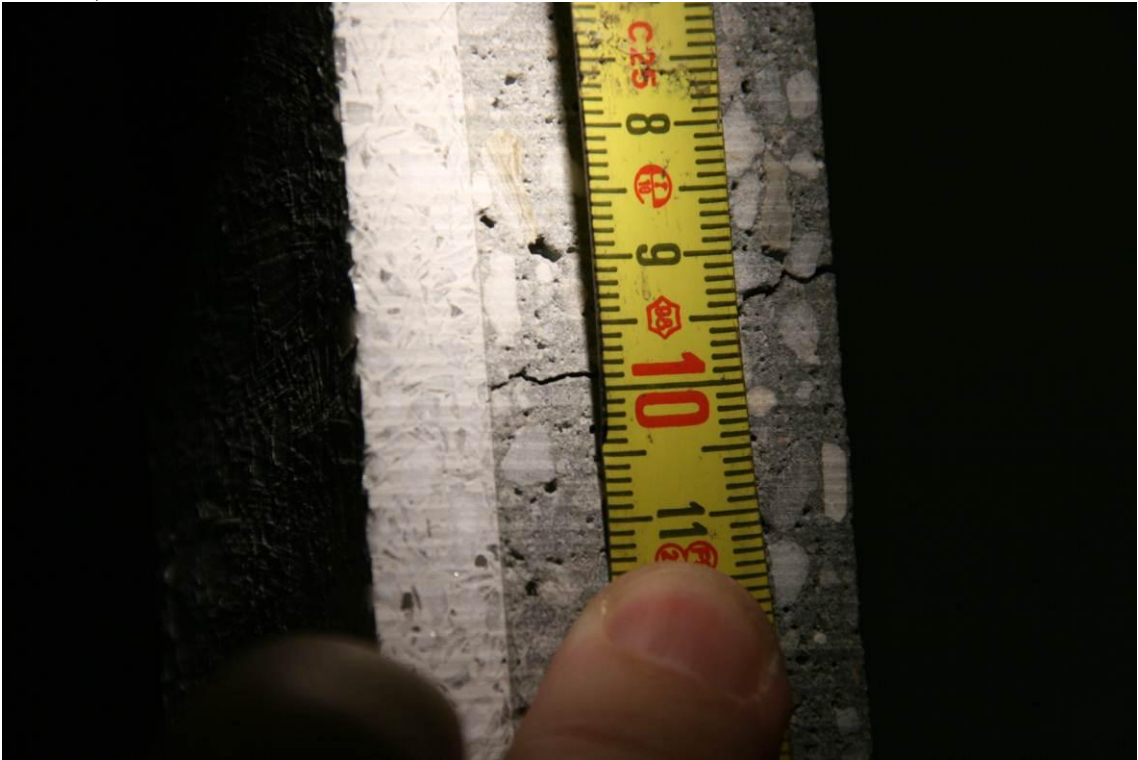
Photo 2, Measuring the width of the crack.

Sample:	Appearance of the terrazzofloor after break of the concrete	Appearance of the terrazzofloor after extra displacement + 30 minutes	Crack width measured from photo (mm)
1	intact	intact	Approx. 0.4
2	intact	intact	Approx. 0.4

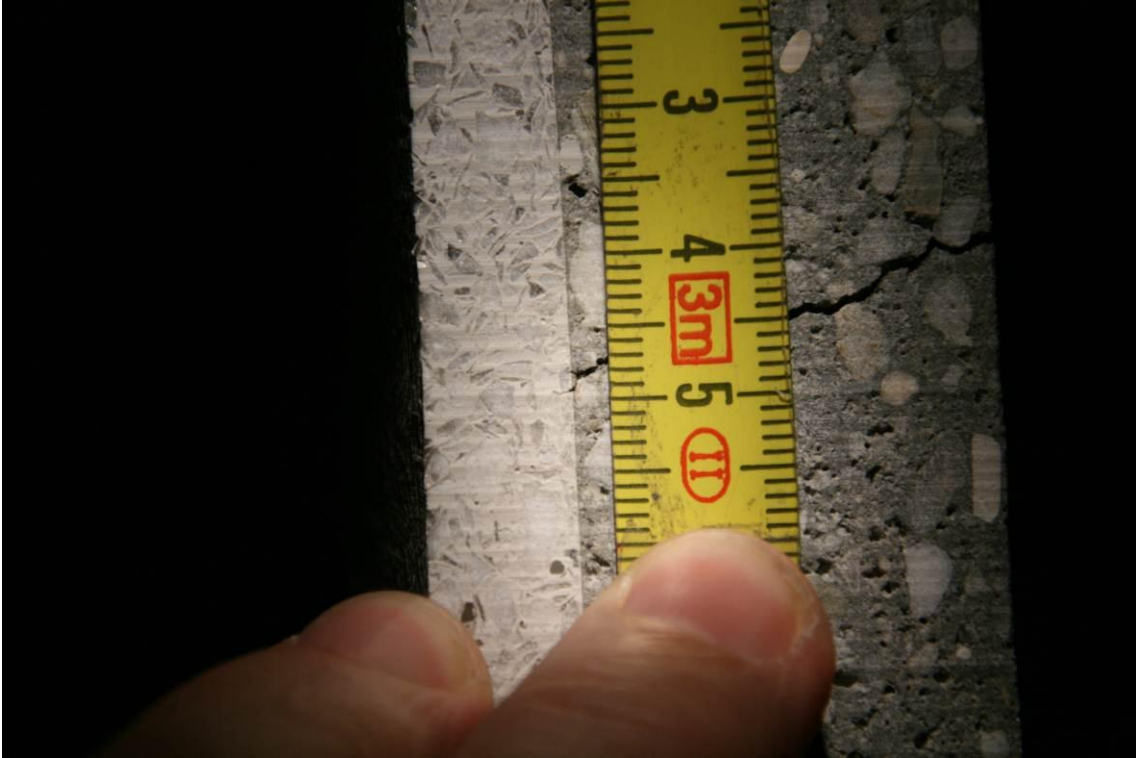
Photo 3, Measuring the width of the crack after extra displacement (approx. 0.4 mm).

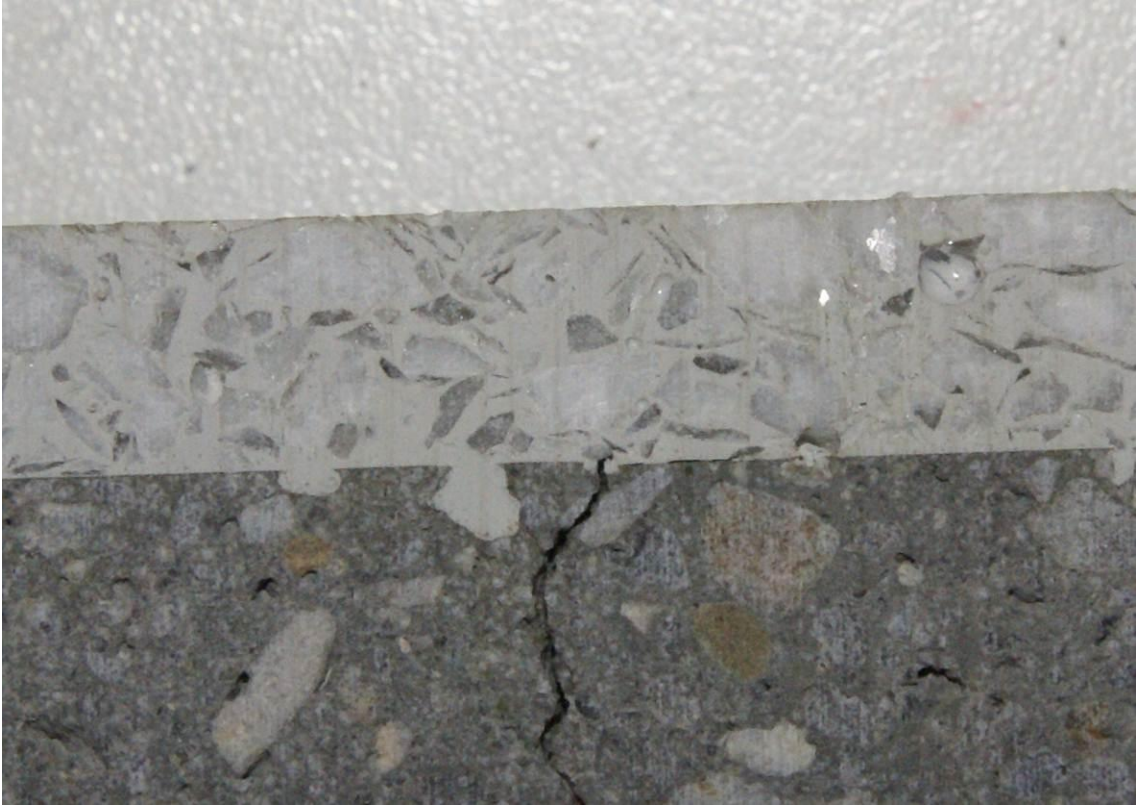
Photo 6, Intact over a 0.5 mm wide crack in the additional test.

Sample:	Applied width (mm)	Appearance of the terrazzo floor at the start of the test	Appearance of the terrazzo floor after X hours
1	0.6	Cracking visible at one side of the sample (photo 4 Appendix C)	After 3 hours, severe cracking is visible on the terrazzo floor surface (photo 5 Appendix C)
2	0.4	Intact (photo 6 Appendix C)	After 6 hours, no further crack development is visible (photo 7 Appendix C)

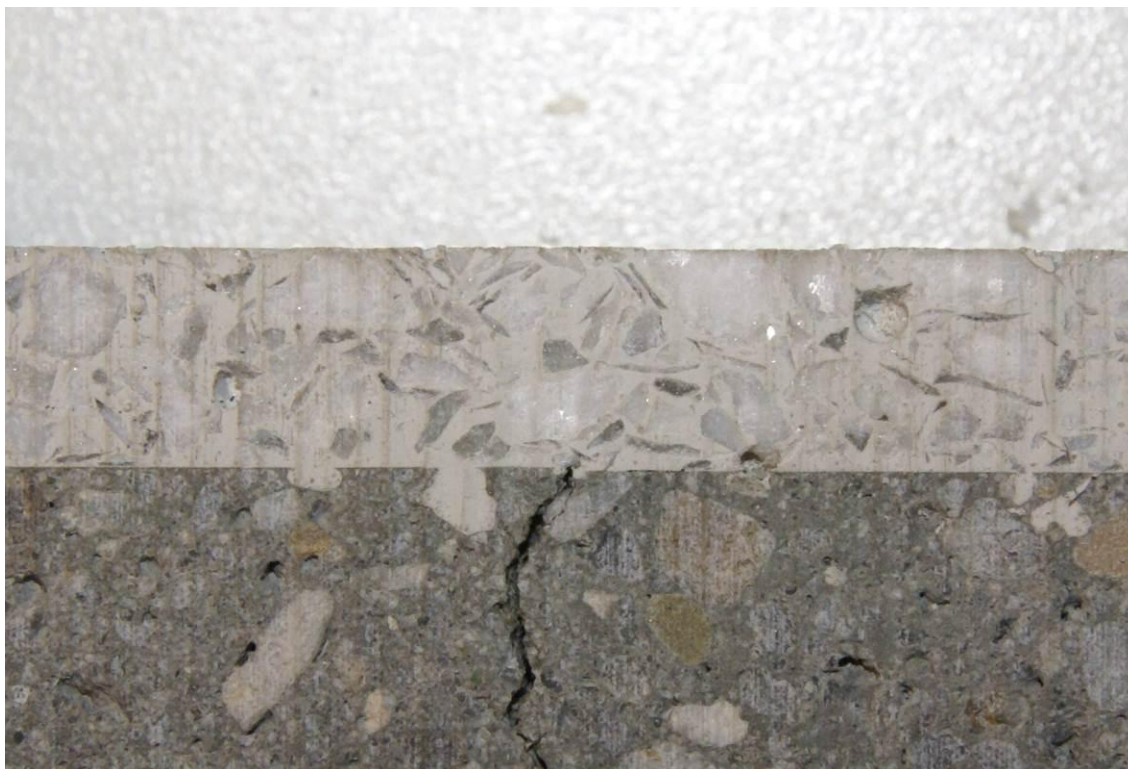
Photo 7, No crack development over a 0.4 mm wide crack after 6 hours in the additional test.

The crack bridging / stone break test shows that a 0.4 mm wide crack in formulation 2 can be bridged by the Senso Terrazzofloor, while a crack of 0.6 mm in the concrete almost certainly will develop cracks in the Senso Terrazzofloor.

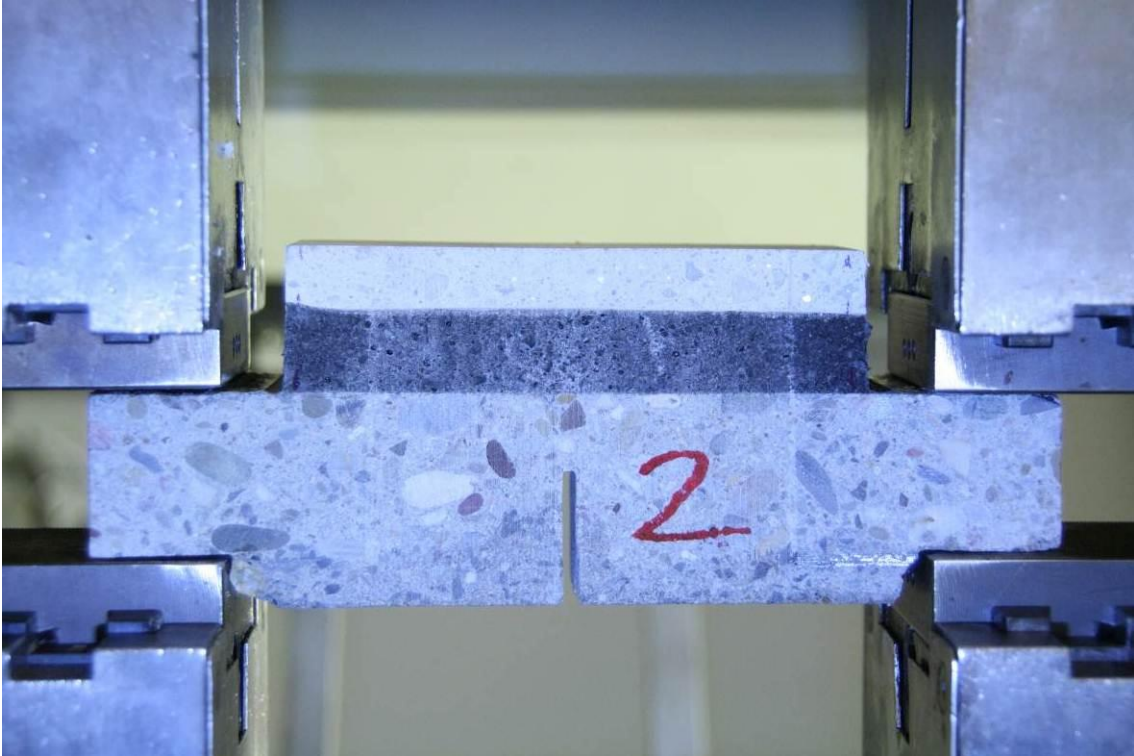
Photo 2, Start position of a test, with cut in the concrete.

The supplied test pieces (new system) showed some irregularities in the tapered ends. These defects were of such a magnitude that breaking was likely to occur at these irregularities instead of in the middle of the samples. In consultation with Senso, it was decided to make a cut (notch) in the back of the test pieces (in the concrete substrate) to initiate a breaking point in the middle of the test pieces, see photos 1 and 2 in Appendix D.

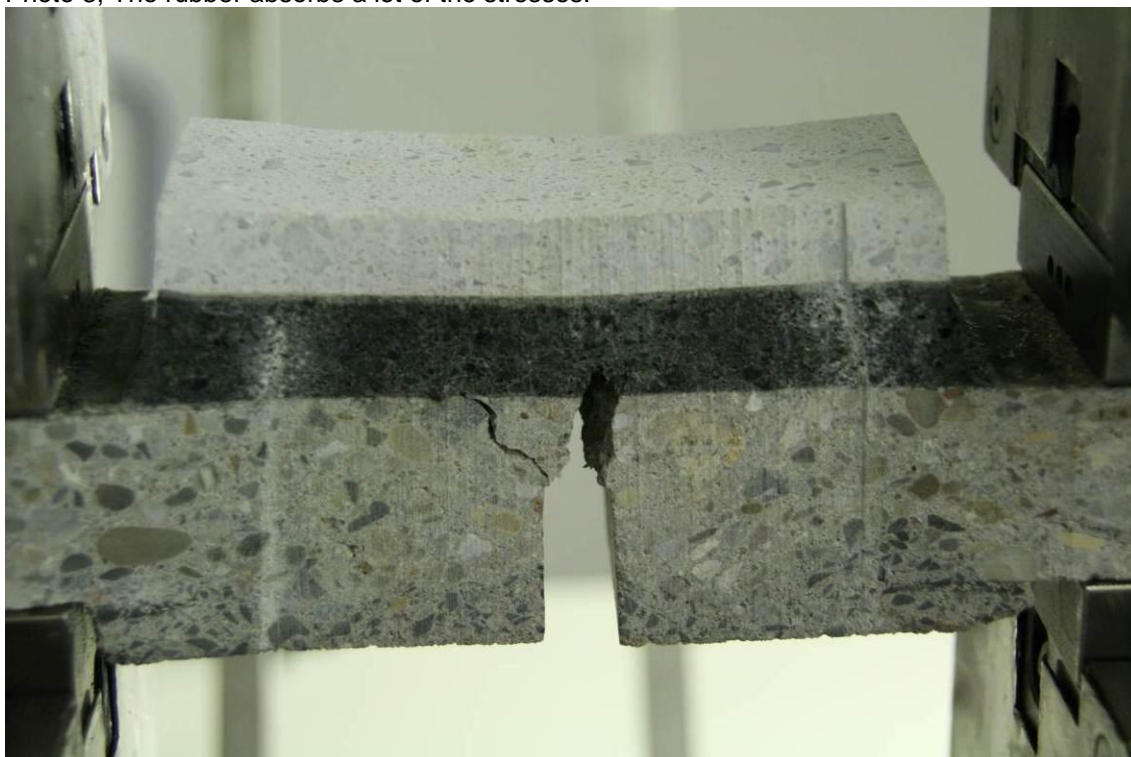
Photo 4, At a certain point the rubber starts to tear. Deformation is visible on sample surface.

By comparing the samples on photo 4 and 5, it is clear that a lot of deformation occurred in the terrazzo floor. Under normal circumstances this kind of deformation is not possible.

As can be seen on photo 4, the rubber absorbs a lot of deformation over the whole length of the sample. As a result, the deformation across the length of the terrazzo top layer is less than across the rest of the sample (see also photo 6, where the same phenomenon can be observed). This means that, as with the samples with formulation 2, the time dependant behaviour is also important. Therefore the same test with placing the samples on a steel bar was repeated with the new system.

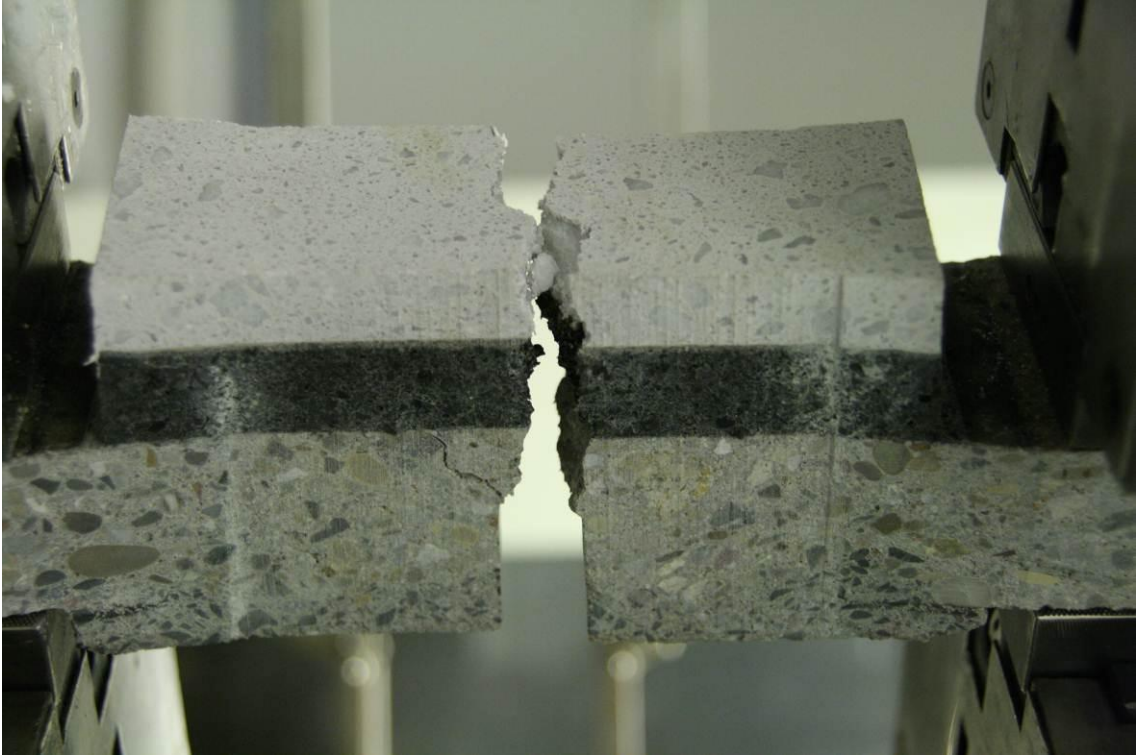
Photo 5, Sample upon completion of test.

The execution of the tests was almost identical to the tests described for formulation 2. Because the new samples behaved much more elastic, the tensile tester was not stopped immediately after the concrete broke, but instead the elongation was slowly increased in time and the behaviour of the samples was studied. Photo 3 shows that the new system is able to bridge much wider cracks. On photo 4 it is visible that the rubber starts to tear at a really wide crack in the substrate. At this point the tensile tester was stopped and the behaviour of the samples was studied. The tear in the rubber layer grew relatively fast. At a certain point the terrazzo floor also cracked, see photo 5.

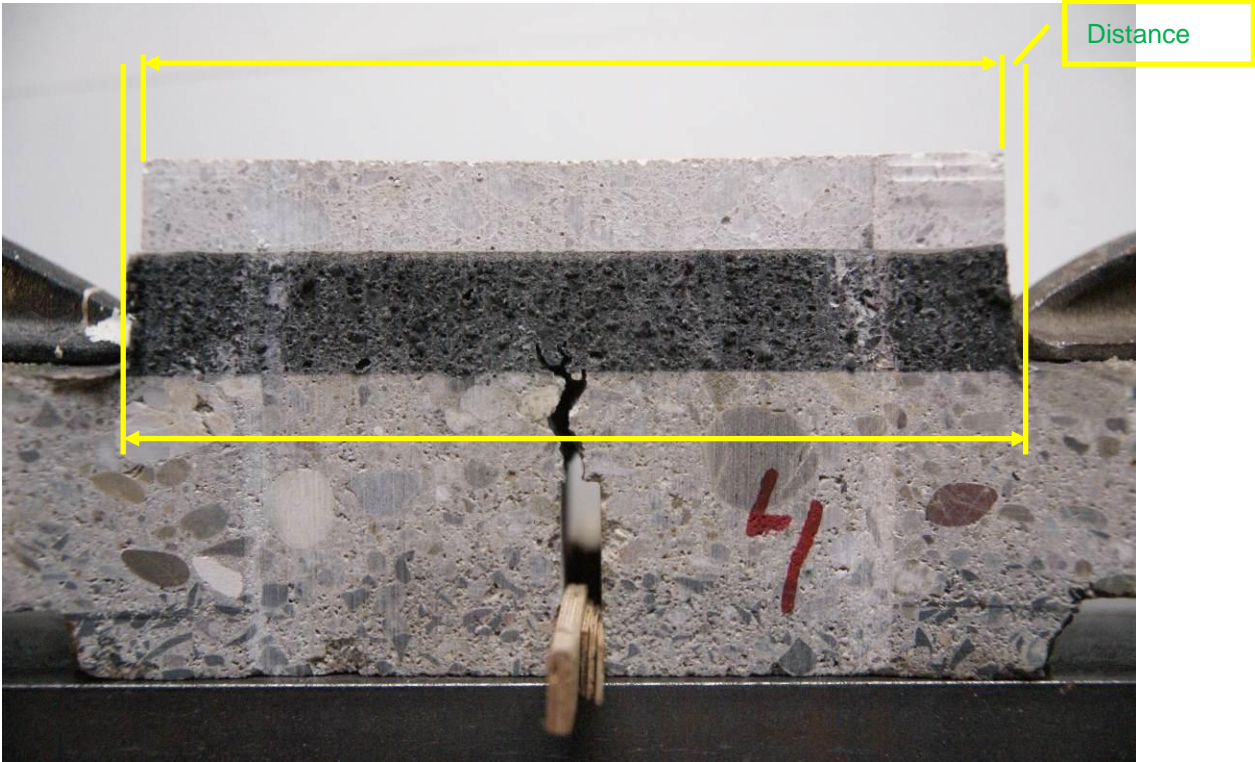
Photo 6, Lasting crack bridging over a crack of 2.6 mm wide.

Then, based on the observed behaviour and the dimensions of the test samples, an estimation was made of the impact of the elongation on the terrazzo floor. Based on this estimation the width was set on 2.60 mm, which resulted in a lasting crack bridging on the sample (see photo 6). The results are summarized in table 8.

Sample:	Applied crack width (mm)	Appearance of the terrazzo floor at the start of the test	Appearance of the terrazzo floor after X hours
3	5	intact	After 60 hours the sample cracked
4	2.6	Intact	After 336 hours a small tear in the rubber is visible but the terrazzo floor itself is still intact (see photo 6 in Appendix D)

This is a significant improvement compared to the Senso terrazzofloor without rubber. The samples however show some significant deformation, which has to be compensated for. Photo 6 in appendix D,

clearly illustrates that the terrazzo floor layer did not completely follow the deformation of the concrete substrate.
